Water Heater Dip Tubes—Why All the Fuss?

by Danny T. Hutchins, PhD

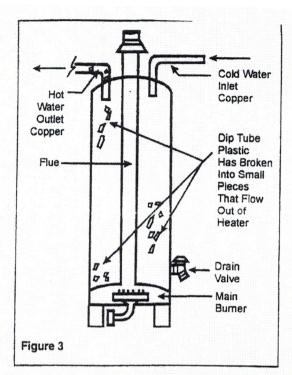
Figure 3 shows that over time, the dip tube continues to change. Cracks and fractures form all over the dip tube surface. The turbulence created inside the tank breaks the tube into increasingly

smaller pieces. The pieces are eventually flushed out of the tank through the hot water outlet. The missing dip tube also reduces the supply of hot water.

1. Flush the debris from the heater tank. install a new dip tube. and flush the strainers and aerators. In order to flush the heater tank, a fullport drain valve has to be installed for each heater. In the case of the apartment complex, the approximate cost to flush the heater and replace the dip tube was \$280 to \$300 per unit. It took 45 minutes to an hour to clean all the strainers. aerators, and fixtures in one apartment.

2. Replace the water heater and clean and flush the strainers and aerators. The cost of this method was projected at \$450 to \$500.

Regardless of the approach you use, the fixtures, strainers, and aerators will have to be cleaned over and over until all of the small pieces of the dip tube are flushed from the distribution piping.
