# Water Heater Dip Tubes—Why All the Fuss?

### by Danny T. Hutchins, PhD

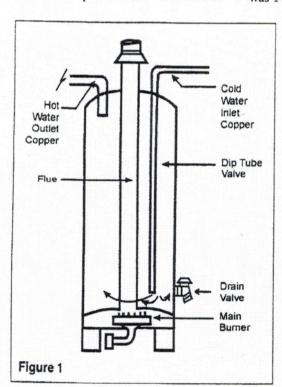
The dip tube is an extension of the cold-water inlet to the water heater tank, extending nearly to the bottom of the tank. Figure 1 shows a normal dip tube as it extends from the copper cold-water inlet pipe down into the tank. The dip tube directs cold water to the bottom of the heater to be heated, allowing hot water to rise to the top of the tank. By directing cold water to the bottom of the tank, the incoming cold water pushes the heated water out in front of it. This allows the hot water to be used without diluting the temperature of the hot water that occupies three-fourths of
